SECTION 32 PROGRAM  
STREAMBANK EROSION CONTROL  
EVALUATION AND DEMONSTRATION  
WORK UNIT 2 - EVALUATION OF EXISTING  
BANK PROTECTION

FIELD INSPECTION OF BANK PROTECTION MEASURES  
ON THE UPPER YAZOO RIVER

February 1978

Inspection Report 4

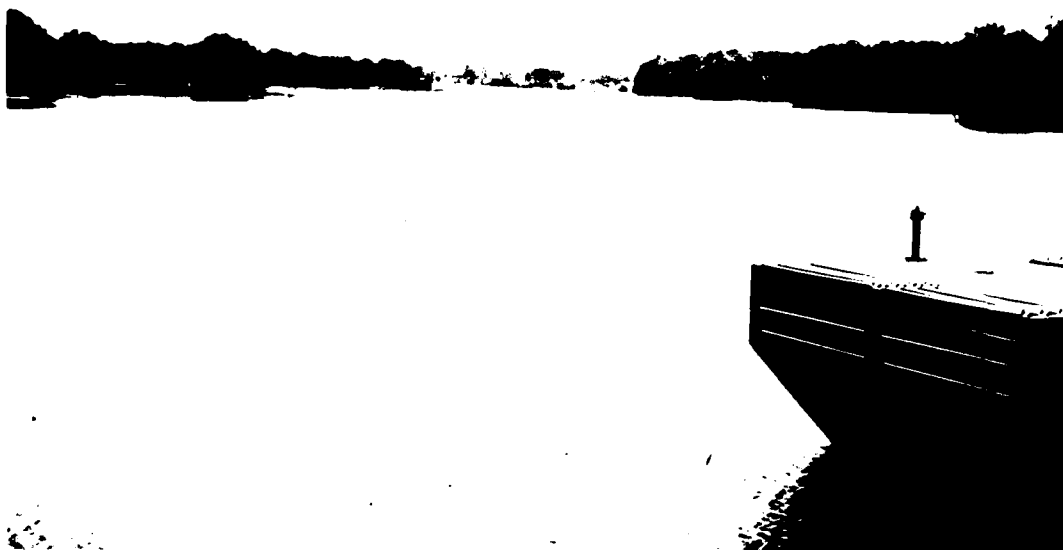
3. The first site observed was the Big Sand Creek near Greenwood, Mississippi, where the Vicksburg District, Soil Conservation Service, and others have undertaken various bank protection projects. About 52 percent of the Big Sand drainage basin is controlled by 40 Soil Conservation Service detention basins that were built in the early 1960's. Drop inlet spillway structures (Photo 1) assist in regulating flow for flood control purposes.

Photo 1. Soil Conservation Service flood control structure

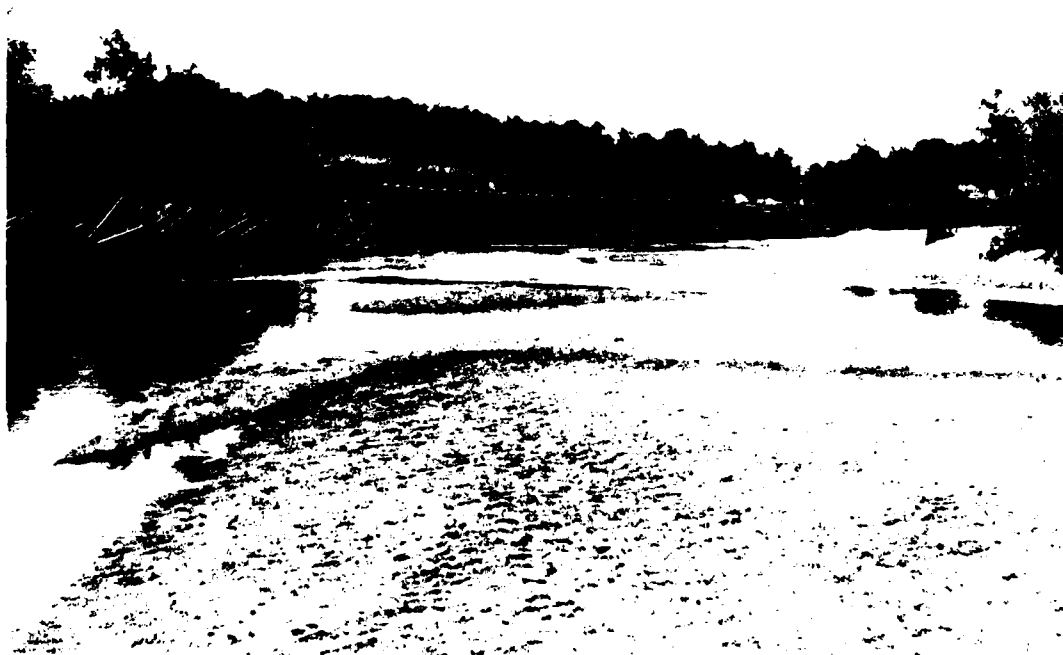
4. The first protection method observed on Big Sand Creek was a system of board fencing parallel to the streambank on the outside bank of a channel bend with concrete jacks upstream and downstream of the fencing (Photos 2 and 3). Fencing and jacks have been used in several locations on the Big Sand Creek and have worked well for the 10 years they have been in place. The next area observed on the Big Sand was where kudzu had been planted to stabilize the bank (Photo 4). The kudzu was not doing an adequate job of stabilizing the bank and had taken over the overbank vegetation.

Photo 2. Board fencing with concrete jacks upstream and downstream

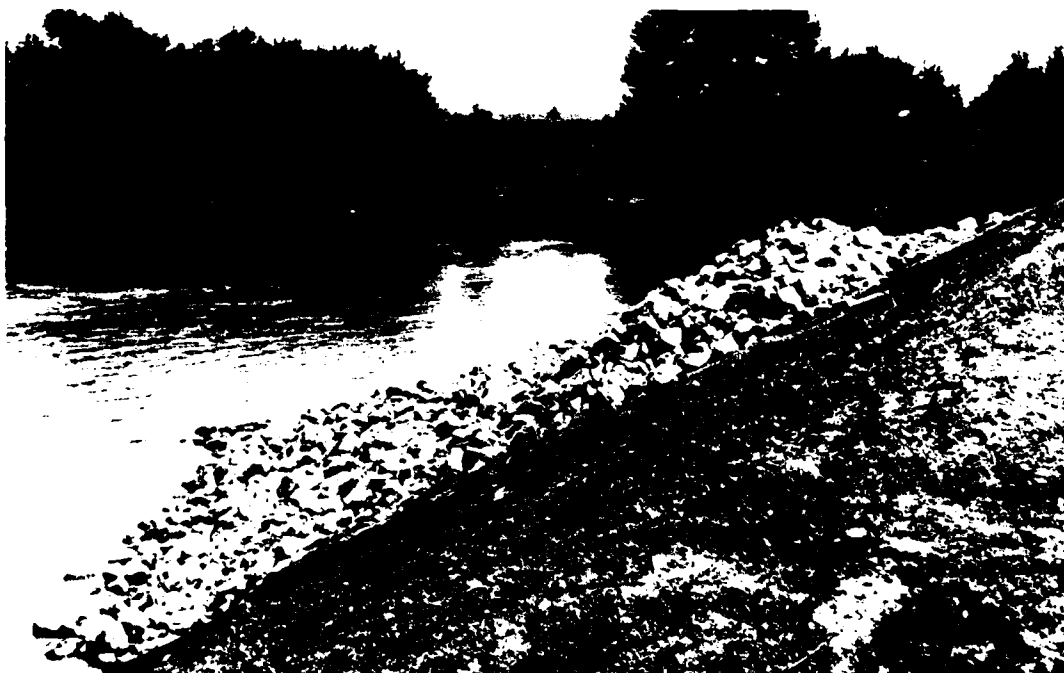
7. Next, riprap revetment was observed at the junction of the Greenwood diversion canal and the Tallahatchie River (Photo 8). The riprap was being placed on a 1V-on-2H slope on a black plastic filter cloth. Toe protection for the revetment was being extended well out into the river.

Photo 8. Riprap placement on black plastic filter material

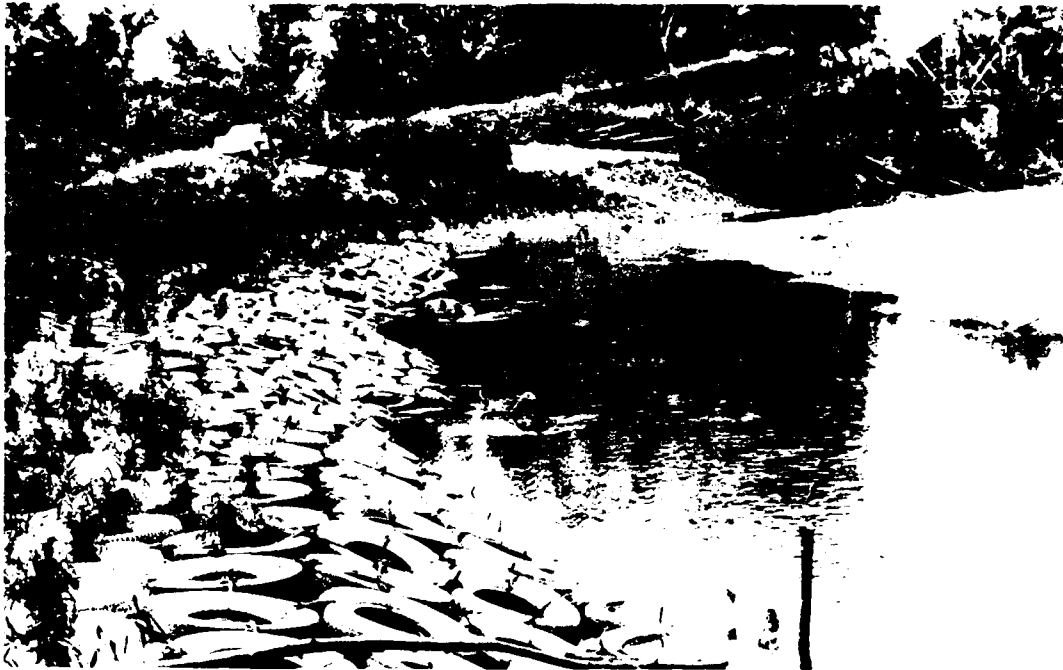
8. The inspection continued to Tillatoba Creek near Charleston, Mississippi, where the Vicksburg District has a very active bank protection program under way. Many of the Section 32 demonstration sites are located on Tillatoba Creek. The first area observed was a mattress of tires connected together with steel bands around the periphery and anchored with cables attached to guy wire anchors (Photos 9 and 10). Willow shoots were planted in the tires and about 50 percent were growing.

Photo 9. Tire mattress

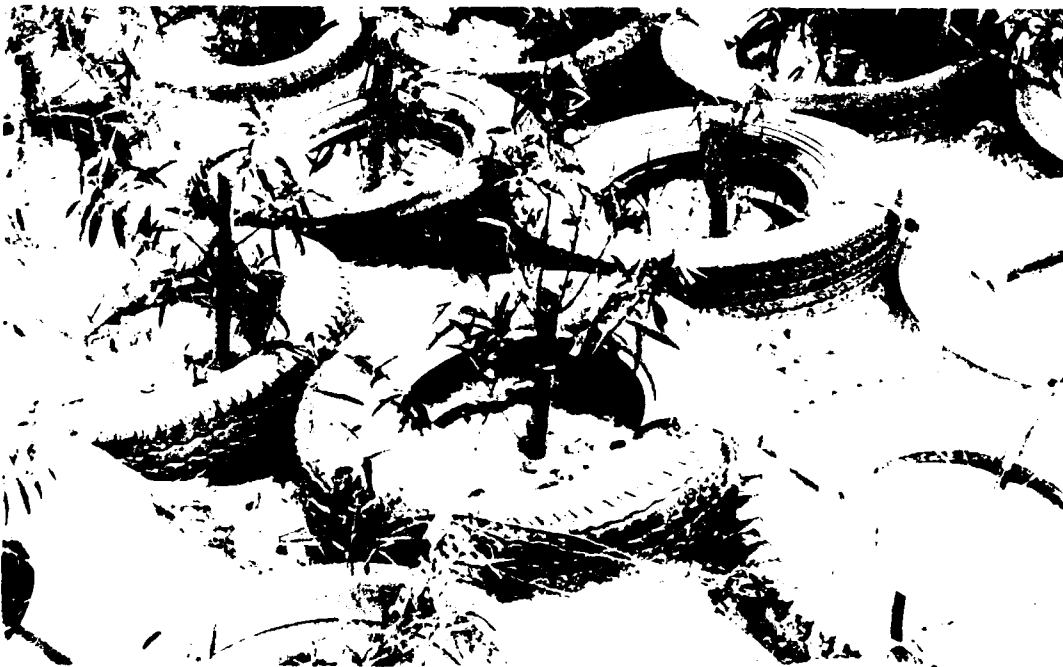
Photo 10. Tire mattress with willow shoots  
planted to increase stability

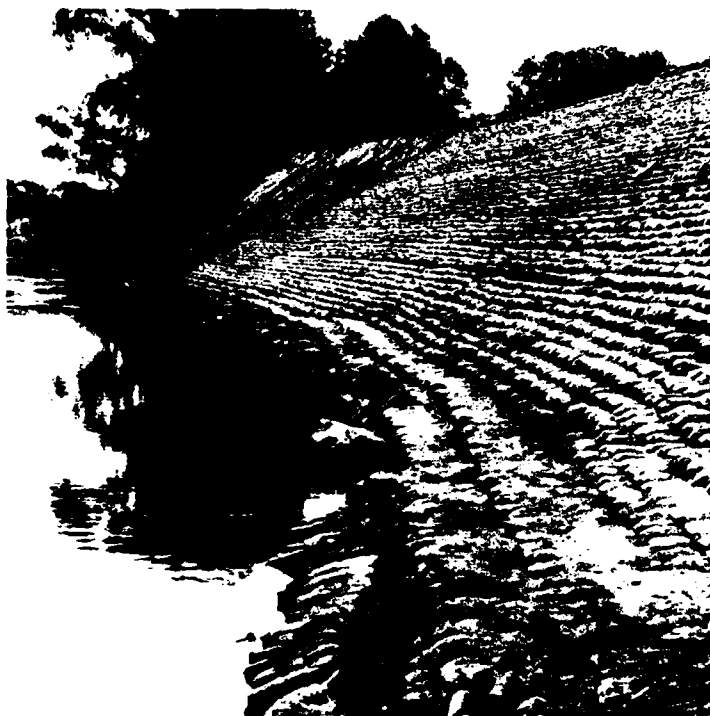
9. Another Section 32 demonstration site was observed consisting of sand-cement bag protection (Photo 11). These bags were placed on a steep slope (1V on 1.5H) and some evidence of toe launching was observed. The next protection method observed on Tillatoba Creek was a site under construction using a double row of wire fencing parallel to the stream (Photos 12 and 13). The space between the double fence will be filled with old tires. Farther upstream a double-row wire fence will be constructed and filled with hay bales.

Photo 11. Sand-cement bags with toe launching

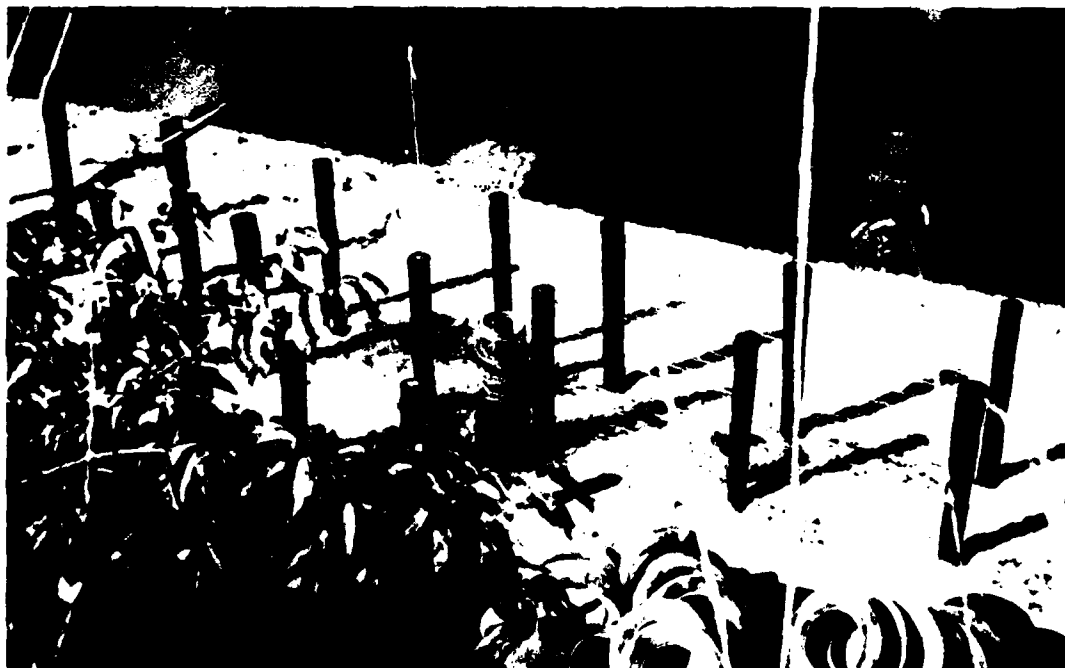
Photo 12. Double-row wire fence (to be filled with tires)

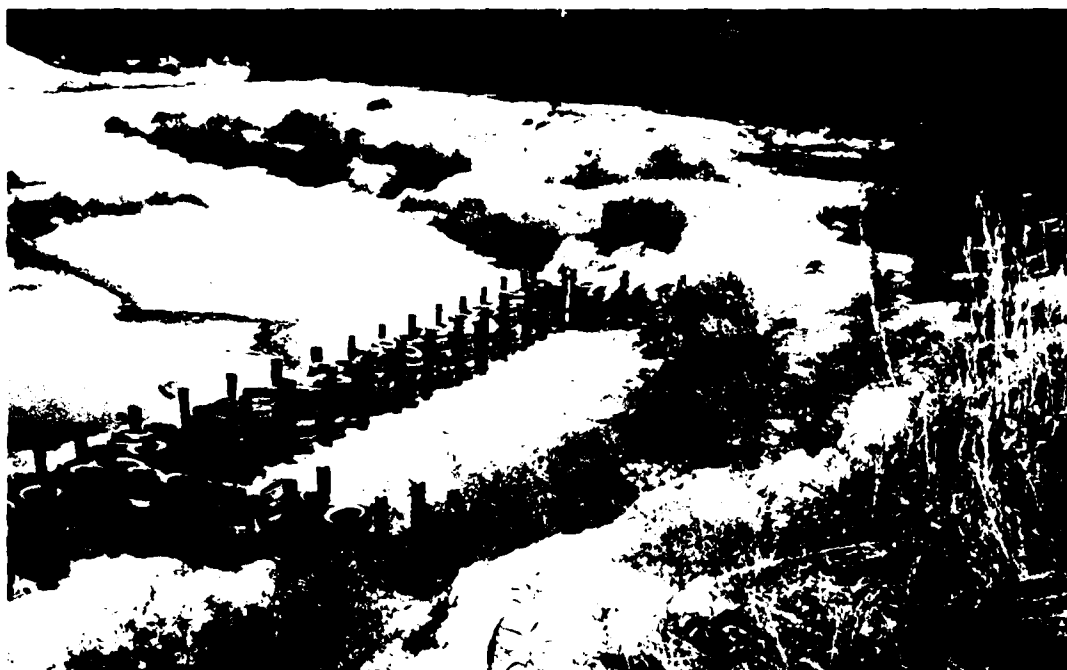
Photo 13. Double-row wire fence with tiebacks
